## **Tree Inspection and Recommendations**

**Shire of Wickepin – Yealering Town Site**

**Ben Jorgensen**

**ISA Certified Arborist AU-0334A**

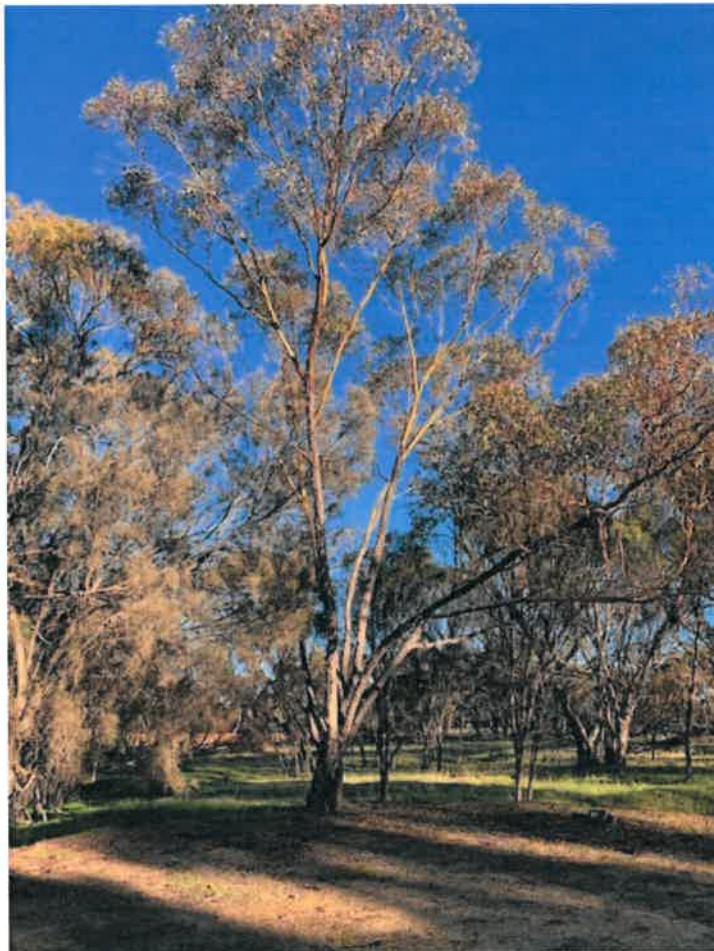
**Tree ID:** Tag # 237

**Comments:** Tree has extended, overweighted leaders overhanging camping area with excessive decay in main stem

**Risk assessment – Tree Part/Target:** Extended leaders overhanging camping area

Likelihood of failure – Probable

Likelihood of impact – Low

Consequences of failure - Significant

**Overall tree risk rating – Low**

**Recommendations:** Remove tree entirely and grind stump

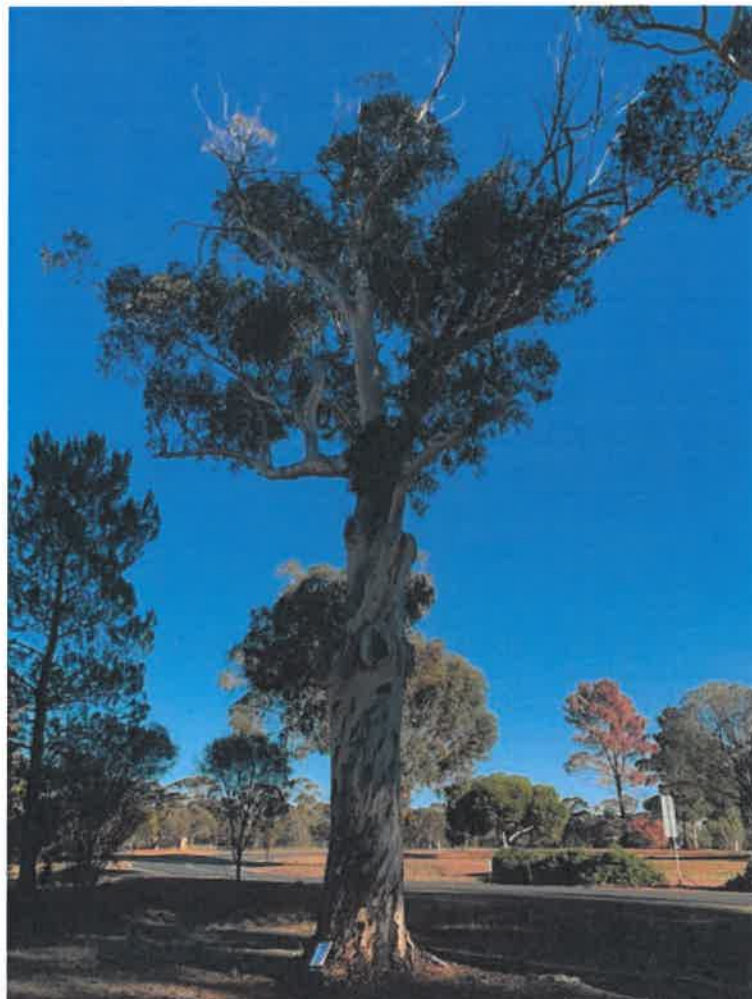
**Tree ID:** Tag # 238

**Comments:** Tree is in an advanced state of decline, major decay column in main stem, large diameter deadwood throughout

**Risk assessment – Tree Part/Target:** Entire crown from major decay column overhanging road

Likelihood of failure – Imminent

Likelihood of impact – Medium

Consequences of failure – Severe

**Overall tree risk rating – High**

**Recommendations:** Remove tree entirely and grind stump

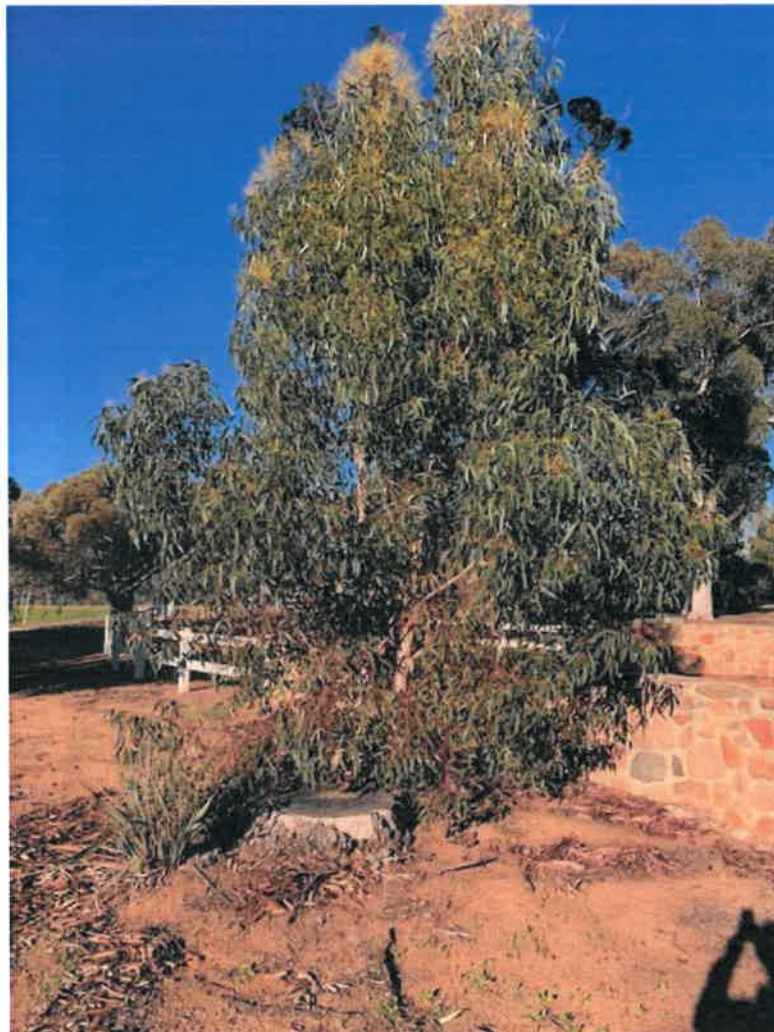
**Tree ID:** Tag # 239

**Comments:** Tree is coppice regrowth from and old stump – defective attachment

**Risk assessment – Tree Part/Target:** Entire tree overhanging entrance to caravan park

**Overall tree risk rating – Low**

**Recommendations:** Remove tree entirely and grind stump

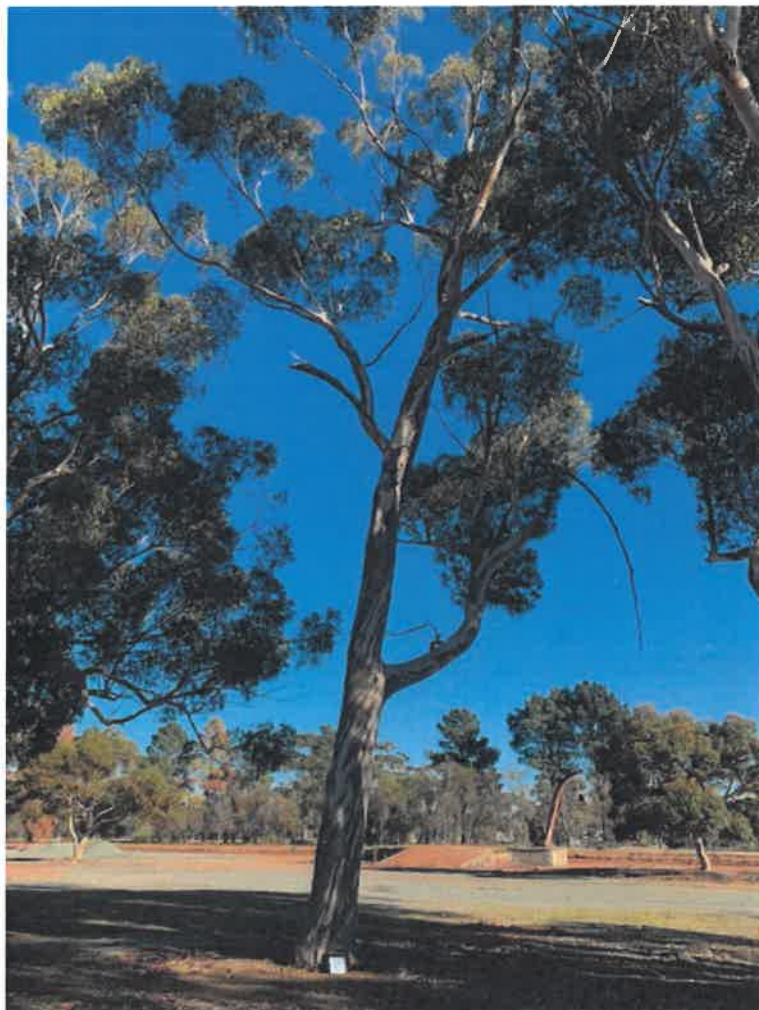
**Tree ID:** Tag # 240

**Comments:** Tree has large area of tissue dysfunction and a decay column in main stem, extensive history of branch failure

**Risk assessment – Tree Part/Target:** Main stem/decaying branch failure, overhanging foot path and storage area

**Overall tree risk rating – Low**

**Recommendations:** Remove tree entirely and grind stump

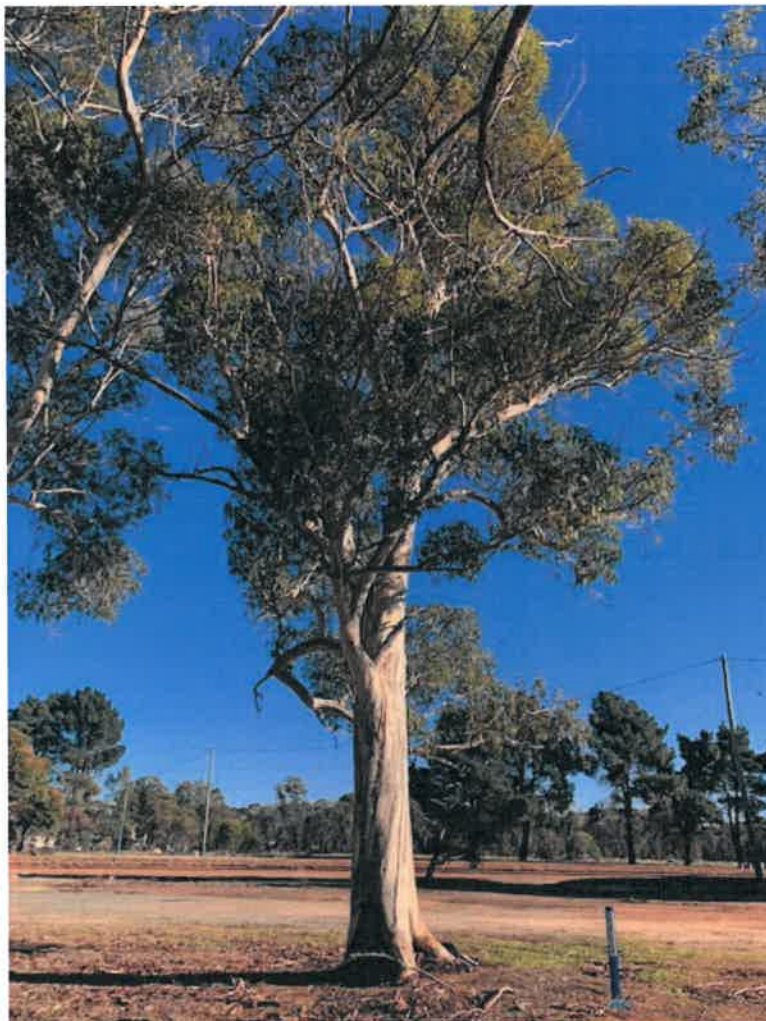
**Tree ID:** Tag # 241

**Comments:** Tree has excess buttress decay, decay column in main stem and an extensive history of branch failure

**Risk assessment – Tree Part/Target:** Entire tree

**Overall tree risk rating – Low**

**Recommendations:** Remove tree entirely and grind stump

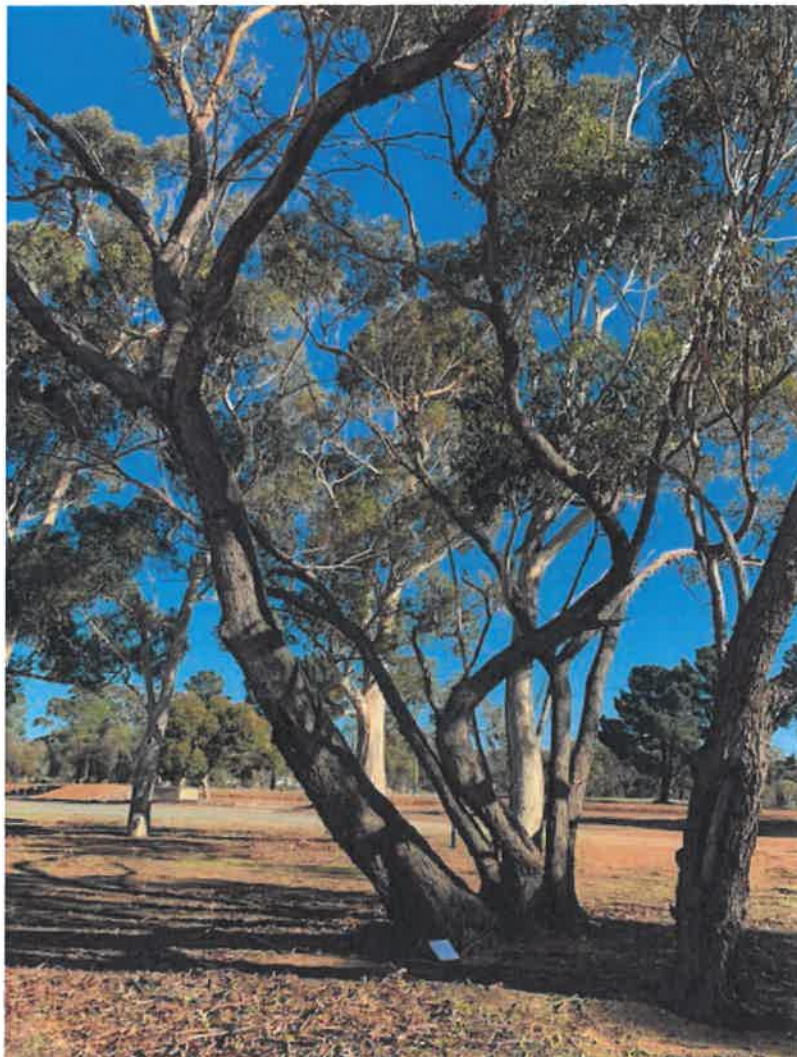
**Tree ID:** Tag # 242

**Comments:** Tree structure is coppice from an old stump, excessive decay present within base, excessive trunk lean with overweighted leaders

**Risk assessment – Tree Part/Target:** Entire tree overhanging foot path

**Overall tree risk rating – Low**

**Recommendations:** Remove tree entirely and grind stump

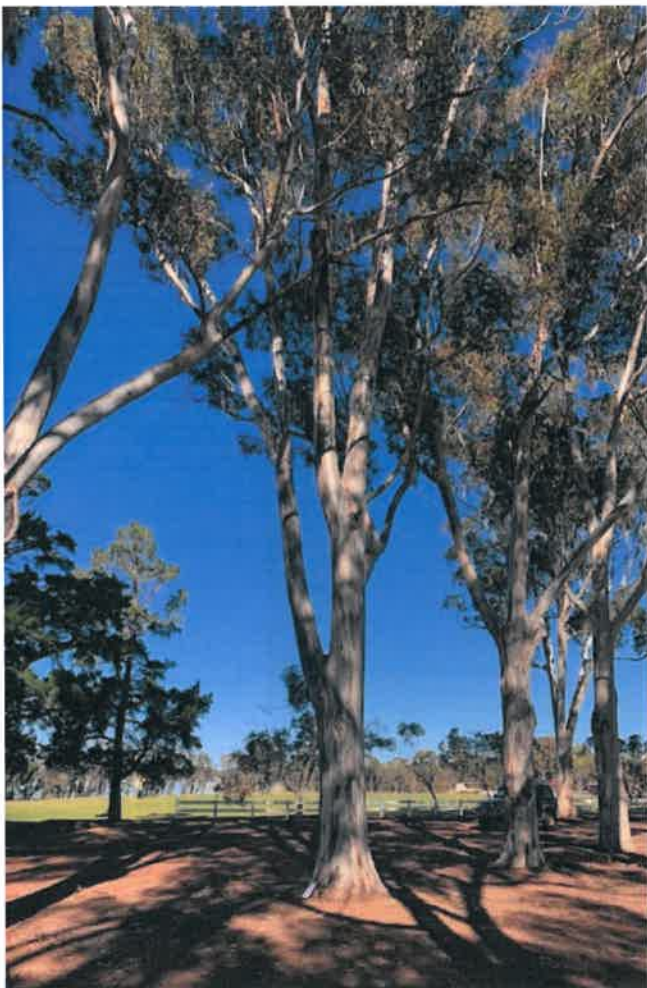
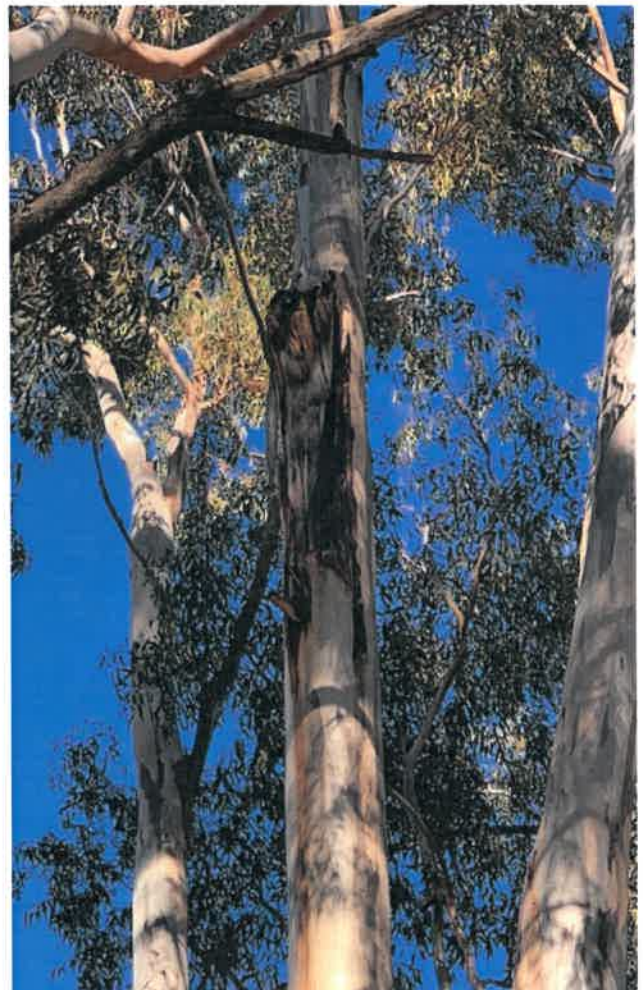
**Tree ID:** Tag # 243

**Comments:** Tree has sustained damage to leader on Eastern side due to branch failure

**Risk assessment – Tree Part/Target:** Damaged leader overhanging car parking area

**Overall tree risk rating – Low**

**Recommendations:** To allow the formation of adequate wound-wood around the area of tissue damage  
Install dynamic bracing sling system to main leaders in basket configuration – 4 tonne load capacity.

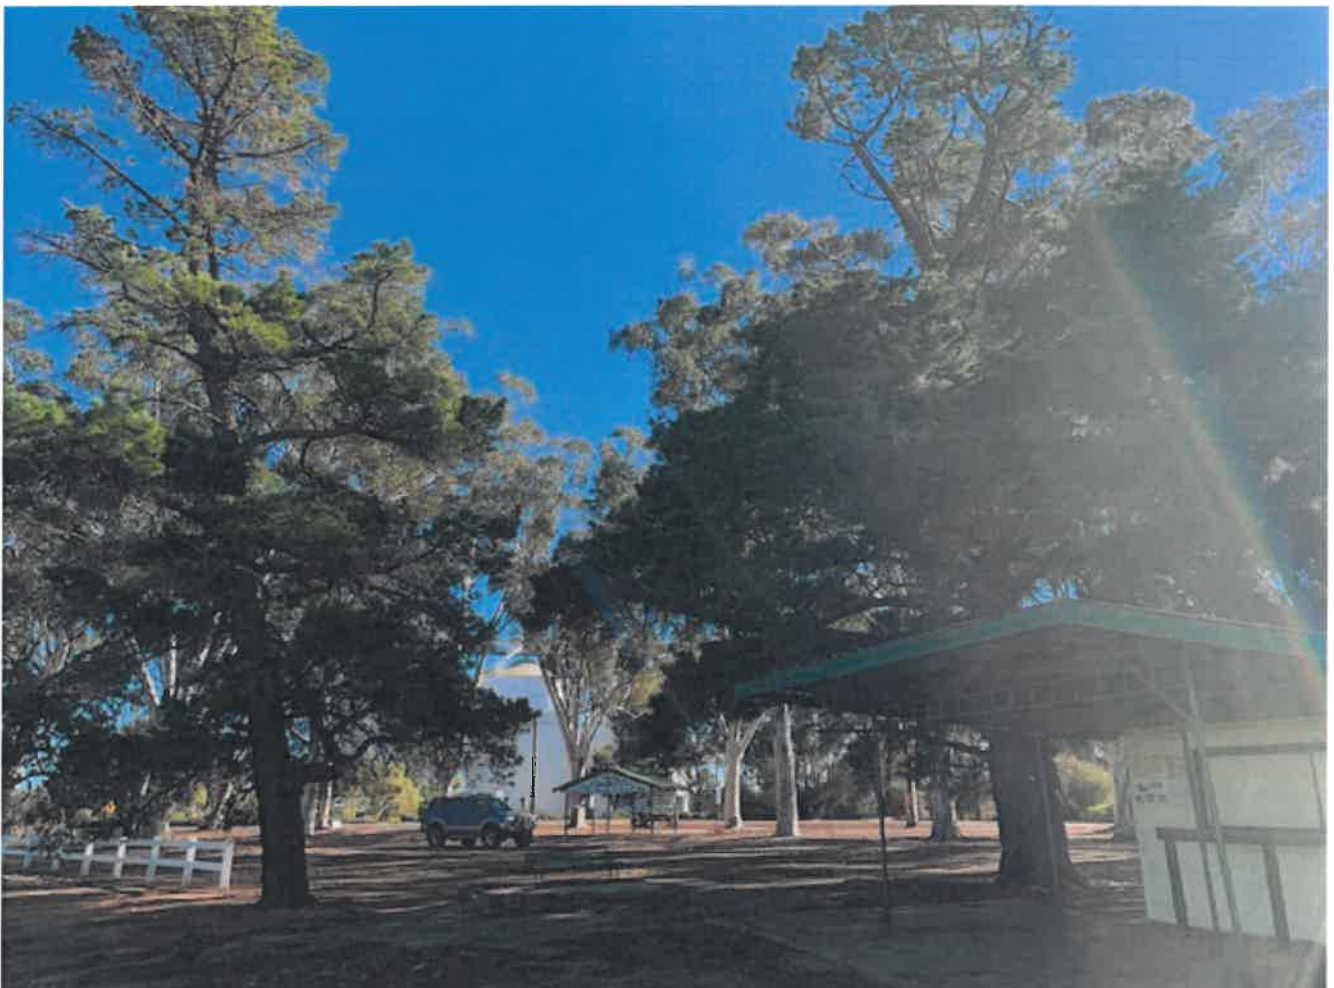
**Tree ID:** Tag # 244

**Comments:** Dead branches throughout crowns

**Risk assessment – Tree Part/Target:** Dead branches overhanging public access area

**Overall tree risk rating – Low**

**Recommendations:** Carry out deadwood removal

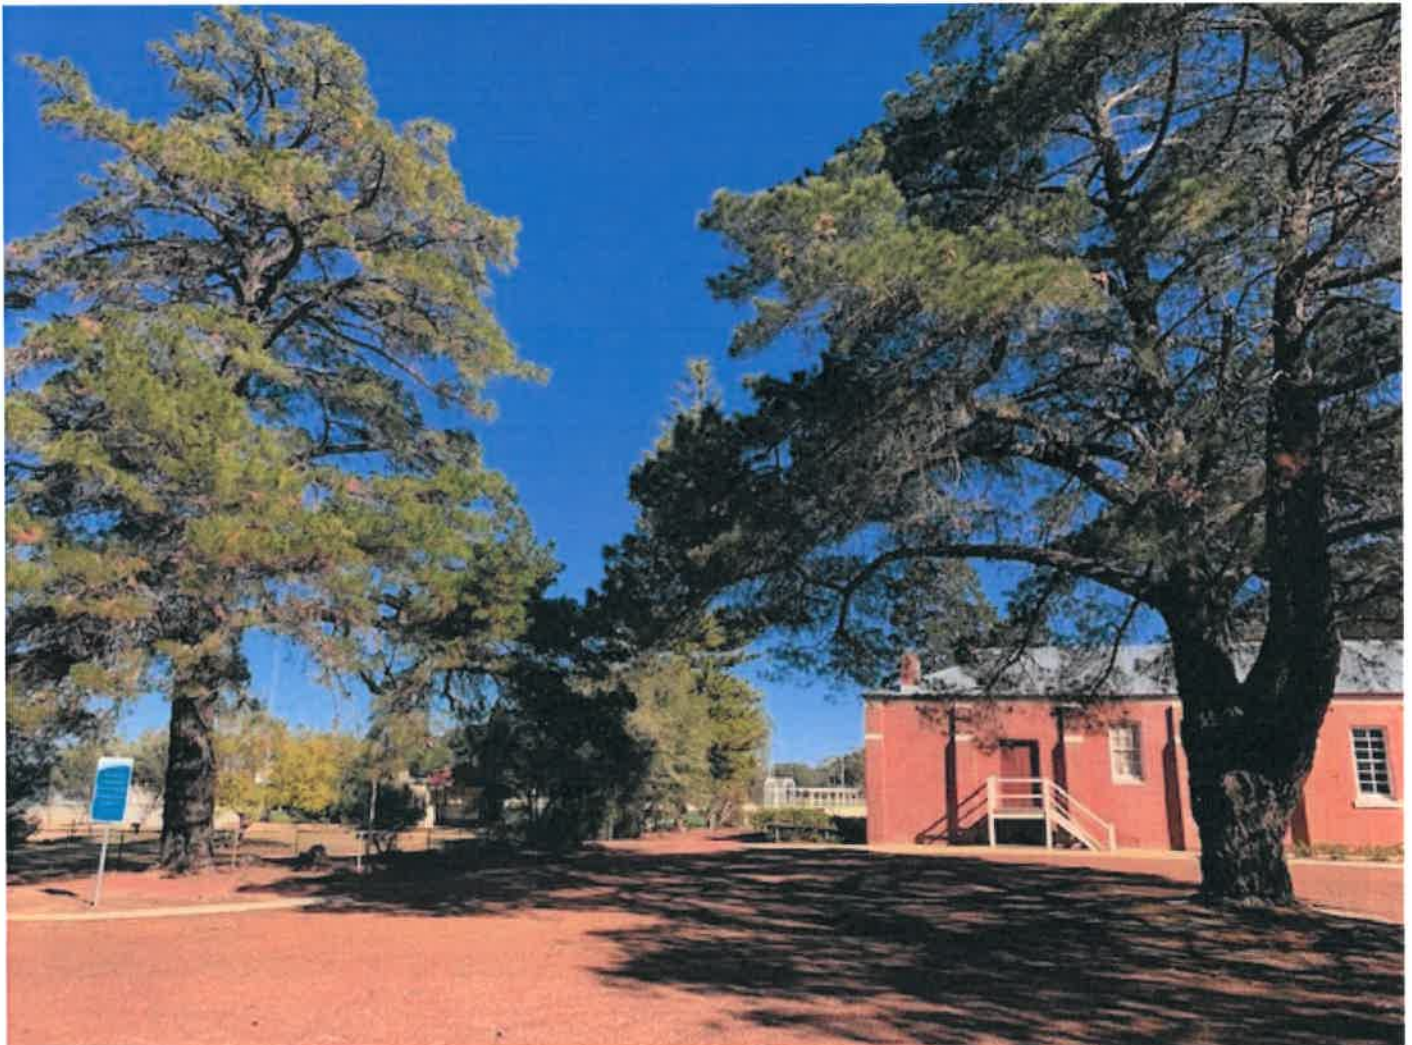
**Tree ID:** Tag # 245

**Comments:** Trees have deadwood throughout and some branch crowding

**Overall tree risk rating – Low**

**Recommendations:** Carry out deadwood removal and crown clean pruning

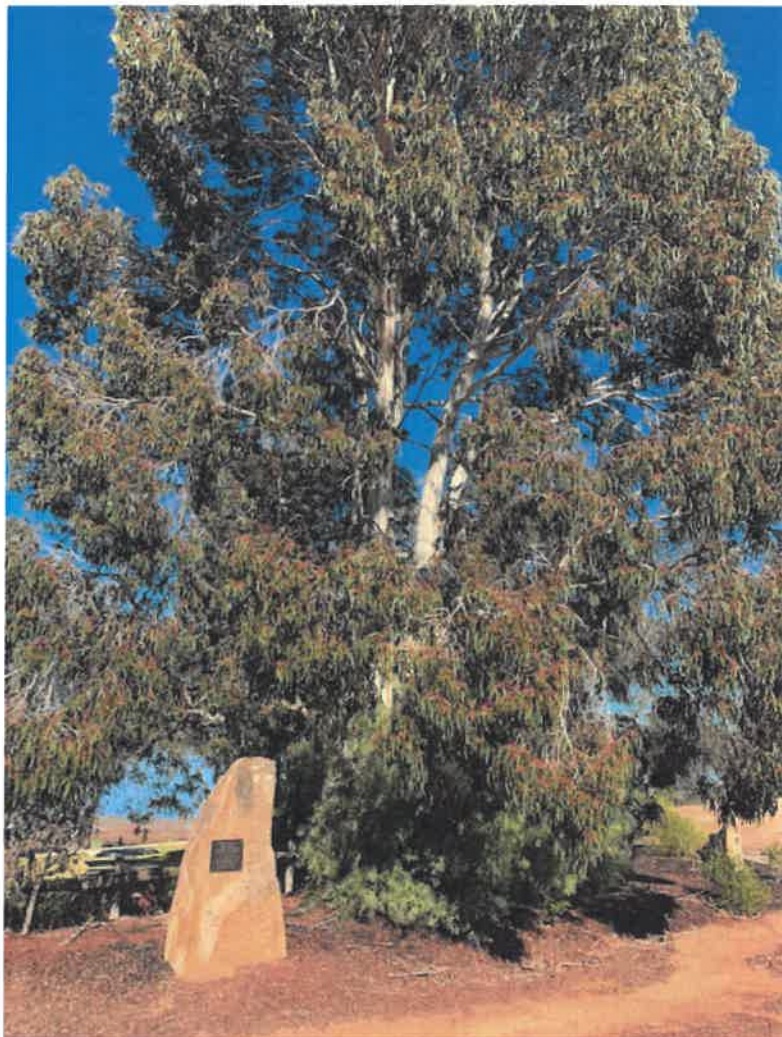
**Tree ID:** Tag # 246

**Comments:** Tree has codominant stem formation with included bark defects at main unions

**Risk assessment – Tree Part/Target:** Leaders with defective branch unions overhanging car park and BBQ area

**Overall tree risk rating – Low**

**Recommendations:** Install dynamic bracing sling system between main leaders in basket formation

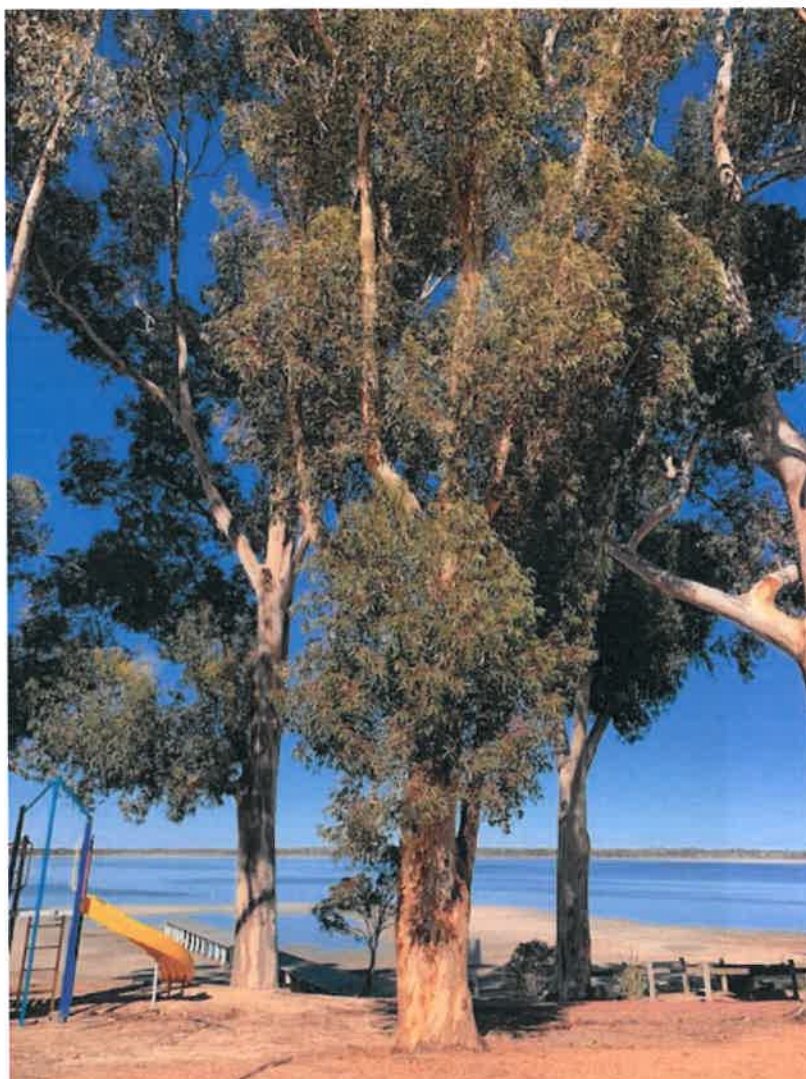
**Tree ID:** Tag # 247

**Comments:** Tree has lost apical dominance – possibly a result of excessive pruning, entirely defective structure

**Overall tree risk rating – Low**

**Recommendations:** Remove tree entirely and grind stump

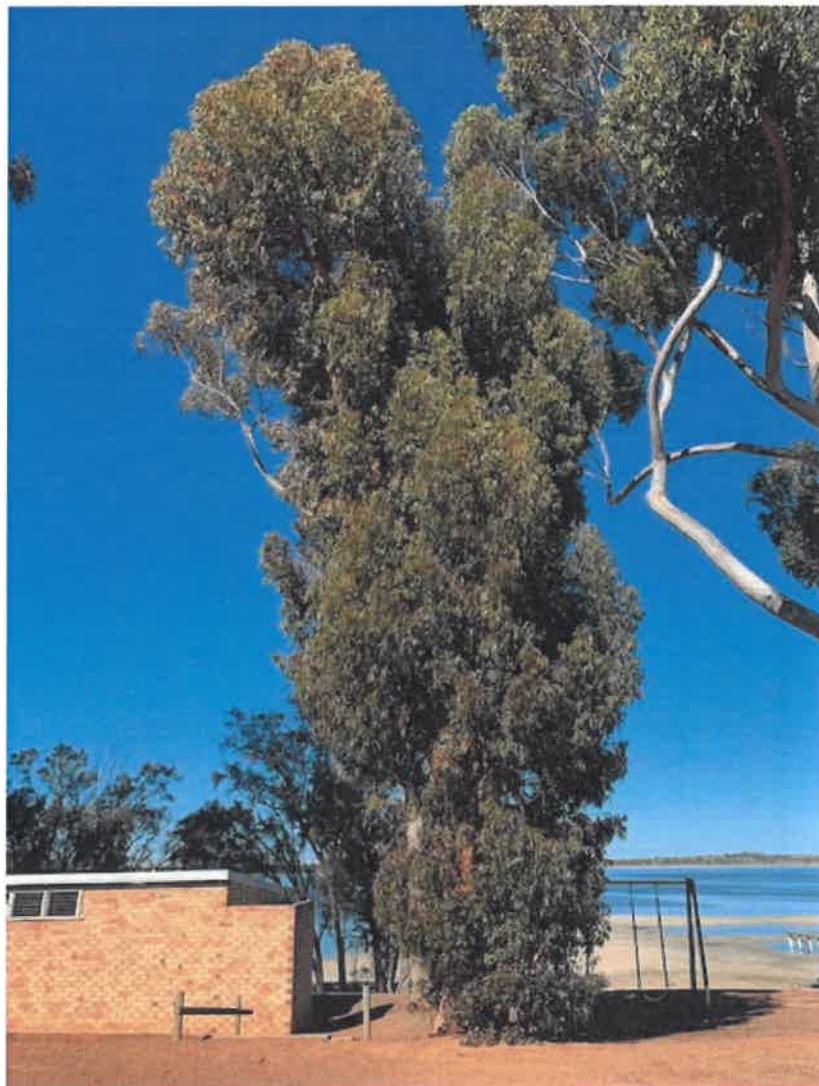
**Tree ID:** Tag 248

**Comments:** Tree has lost apical dominance and now has entirely defective structure – Possibly a result of excessive and incorrect pruning methods

**Overall tree risk rating – Low**

**Recommendations:** Remove tree entirely and grind stump

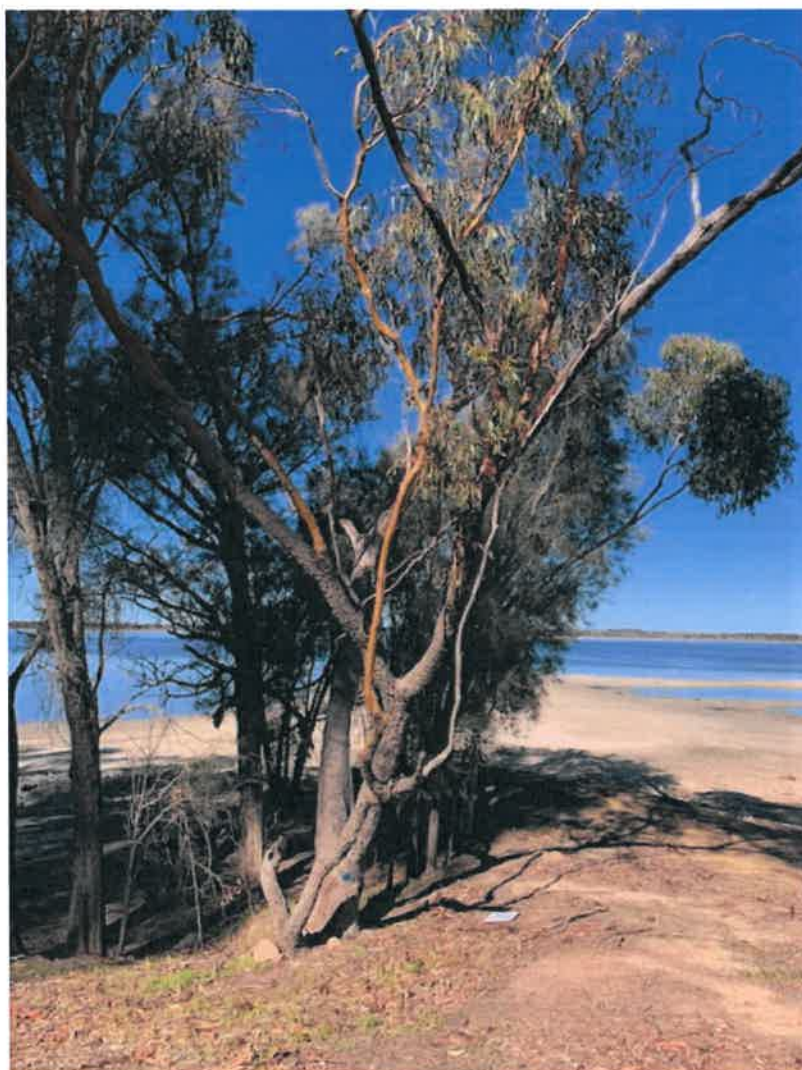
**Tree ID:** Tag # 249

Likelihood of failure – Probable

**Overall tree risk rating – Low**

**Recommendations:** Remove tree entirely and grind stump

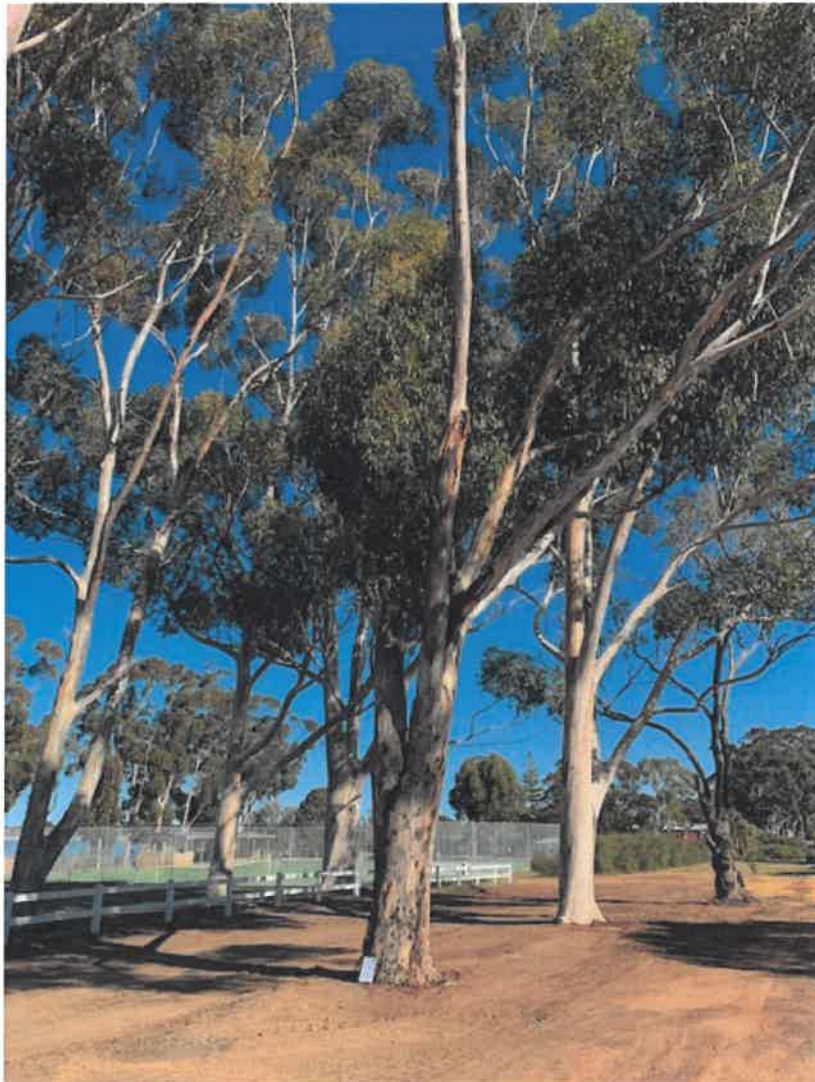
**Tree ID:** Tag # 250

**Comments:** Tree has large areas of tissue dysfunction on main leaders, included bark defect in main unions and an extensive history of failure

**Risk assessment – Tree Part/Target:** Defective crown structure overhanging Road

**Overall tree risk rating – Low**

**Recommendations:** Remove tree entirely and grind stump

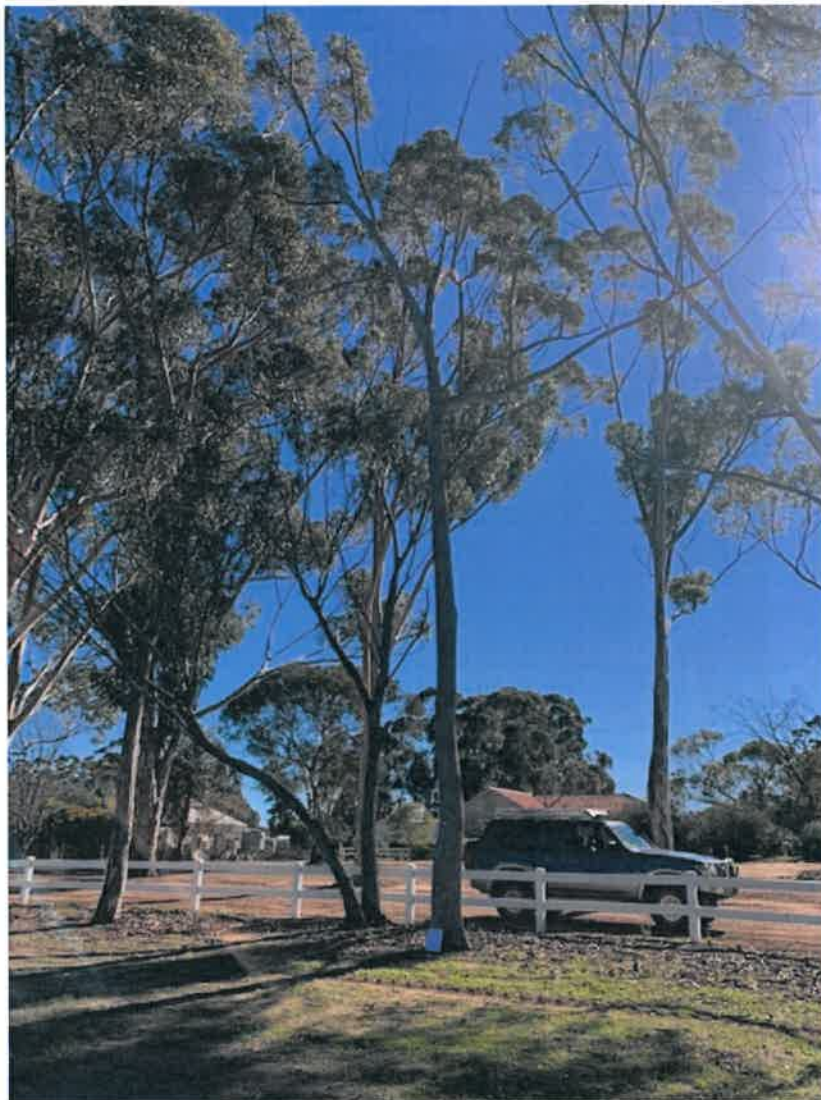
**Tree ID:** Tag # 251

Likelihood of failure – Imminent

**Overall tree risk rating – Low**

**Recommendations:** Remove tree entirely and grind stump

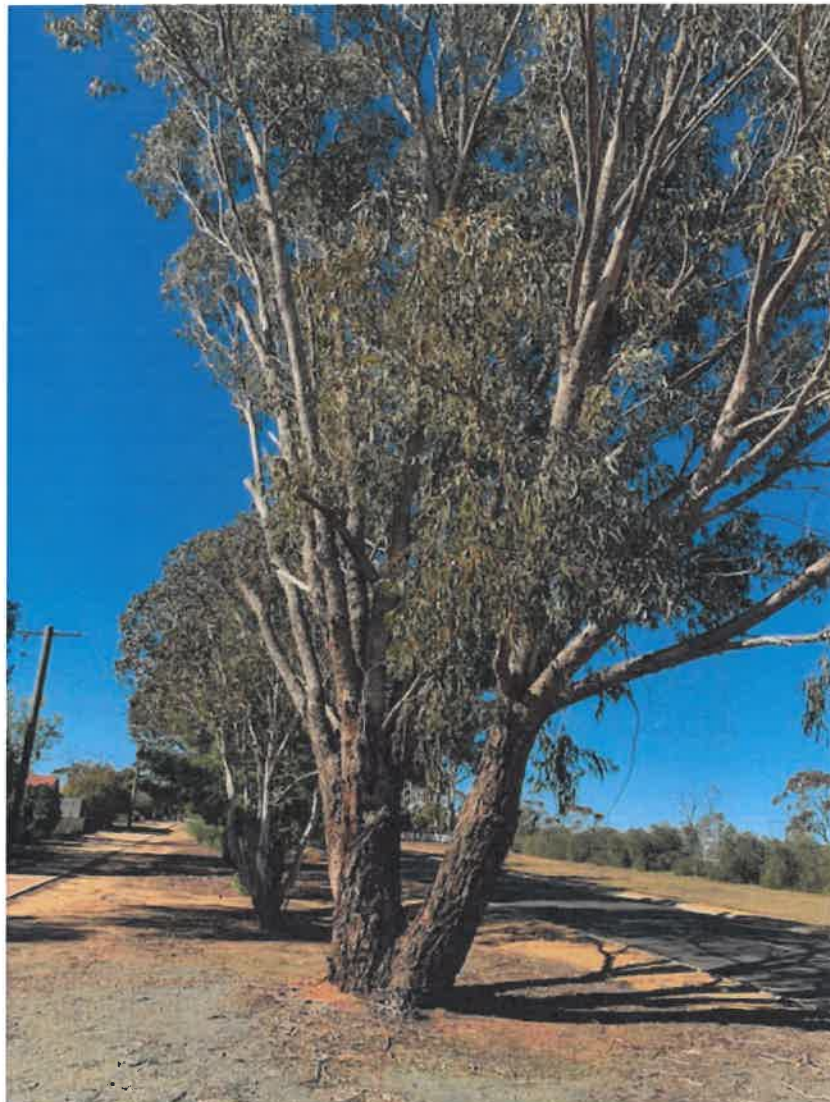
**Tree ID:** Tag # 252

**Comments:** Entirely defective crown structure, decay column in main stem, branch attachment defects throughout crown

**Risk assessment – Tree Part/Target:** Defective crown overhanging foot path, power lines and road

**Overall tree risk rating – Moderate**

**Recommendations:** Remove tree entirely and grind stump

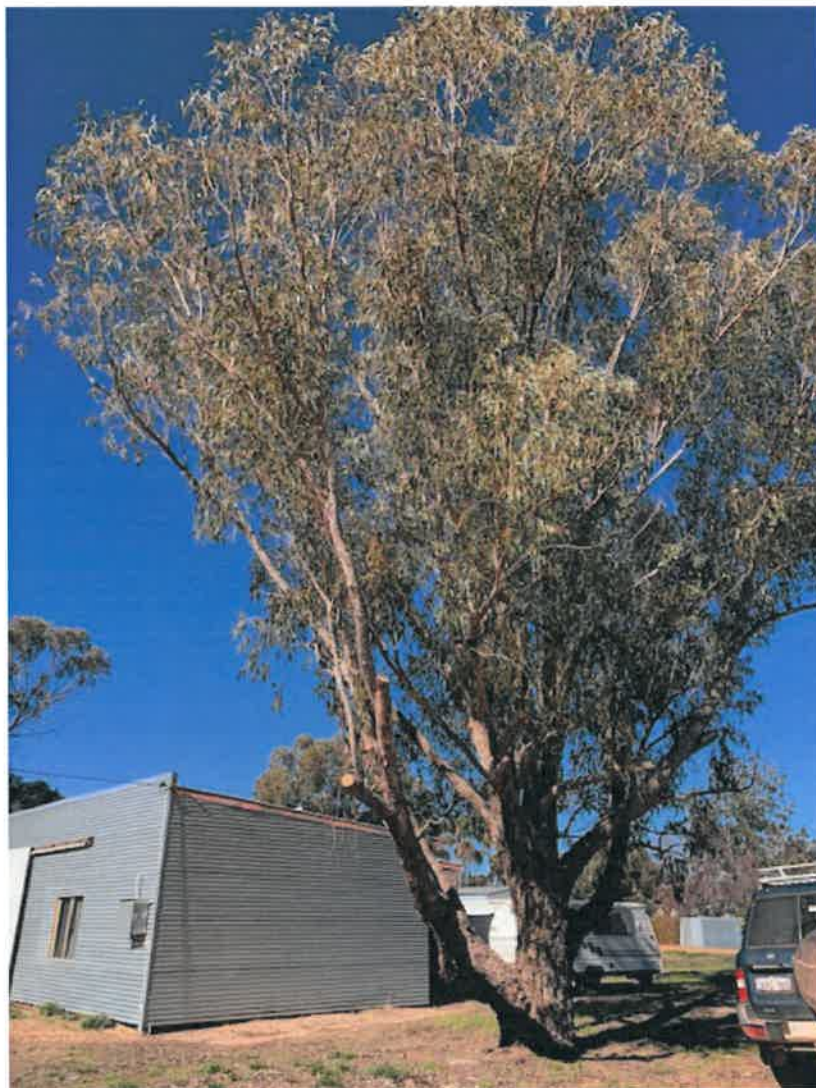
**Tree ID:** Tag # 253

Likelihood of failure – Probable

**Overall tree risk rating – Low**

**Recommendations:** Carry out remedial pruning to correct recent indiscriminate pruning

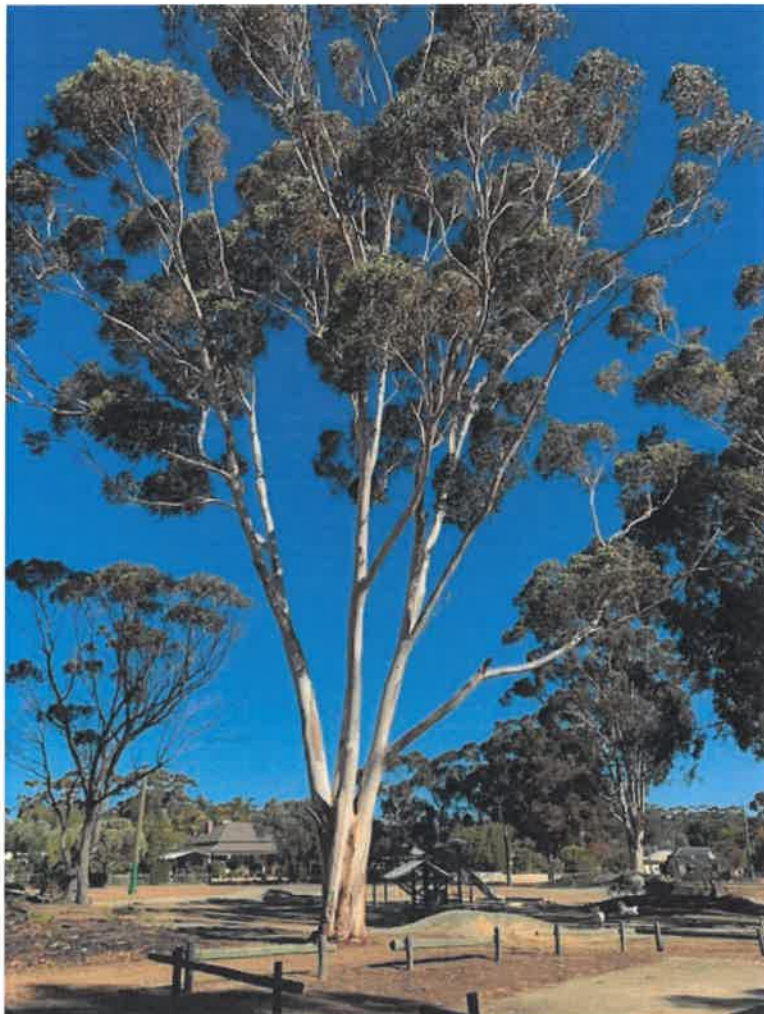
**Tree ID:** Tag # 254

**Comments:** Tree has codominant stem formation with defective branch union, large cracks with separation in man unions

**Risk assessment – Tree Part/Target:** Leader with large crack in union overhanging BMX track and basketball court

Likelihood of failure – Imminent

**Overall tree risk rating – High**

**Recommendations:** High Priority – Remove tree entirely and grind stump

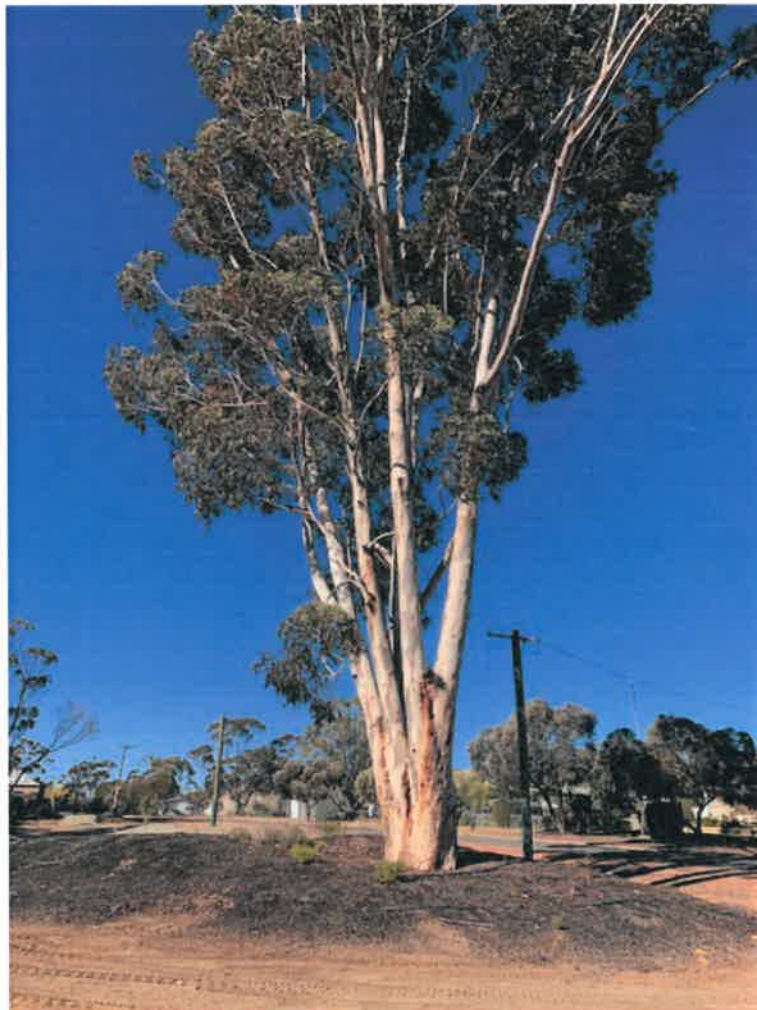
**Tree ID:** Tag # 255

**Comments:** Tree has codominant stem formation with included bark defect in all main unions

**Risk assessment – Tree Part/Target:** Leaders with defective unions overhanging road, powerlines, BMX track

**Overall tree risk rating – Low**

**Recommendations:** Install dynamic bracing sling system between all main leaders – basket formation  
4 tonne load capacity

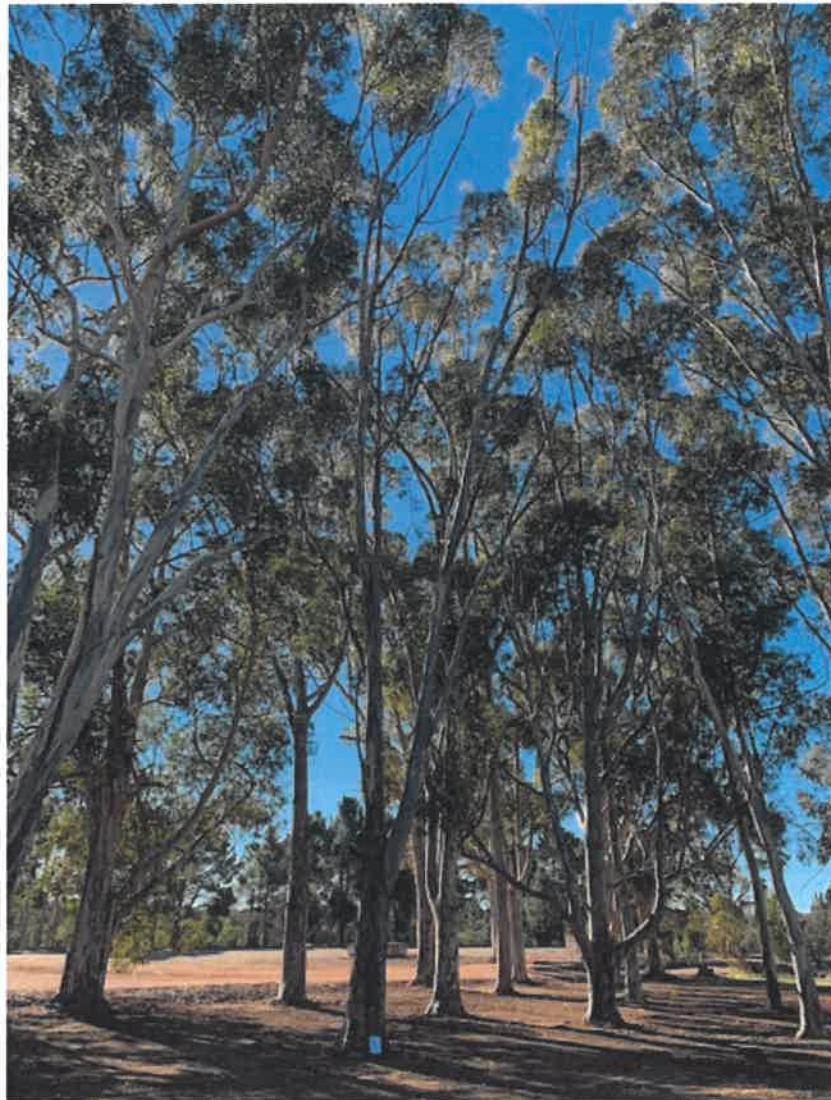
**Tree ID:** Tag # 256

Likelihood of failure – Probable

**Overall tree risk rating – Low**

**Recommendations:** Remove tree entirely and grind stump
