Toolibin Lake Natural Diversity Recovery Catchment Project Summary

updated 2013

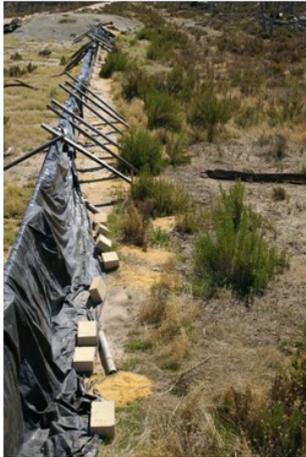
Old wooden gates

The gates and structure was upgraded in 2010. The old timber gates and posts were replaced with aluminium.

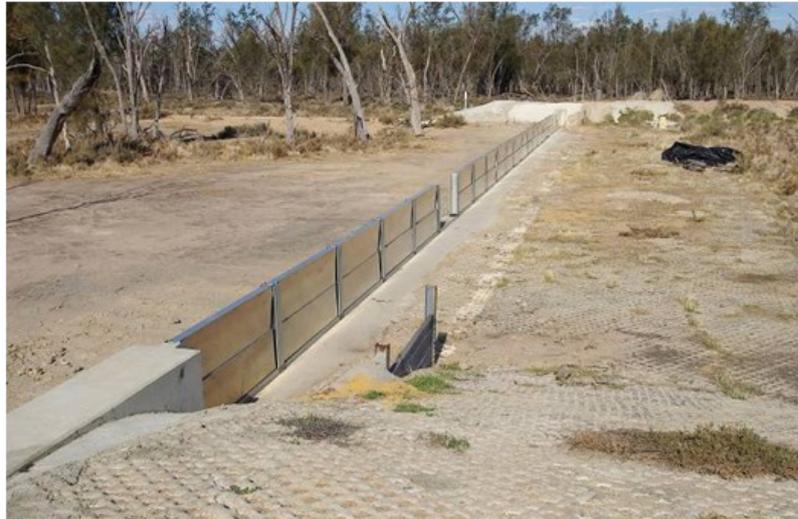
New aluminium gates

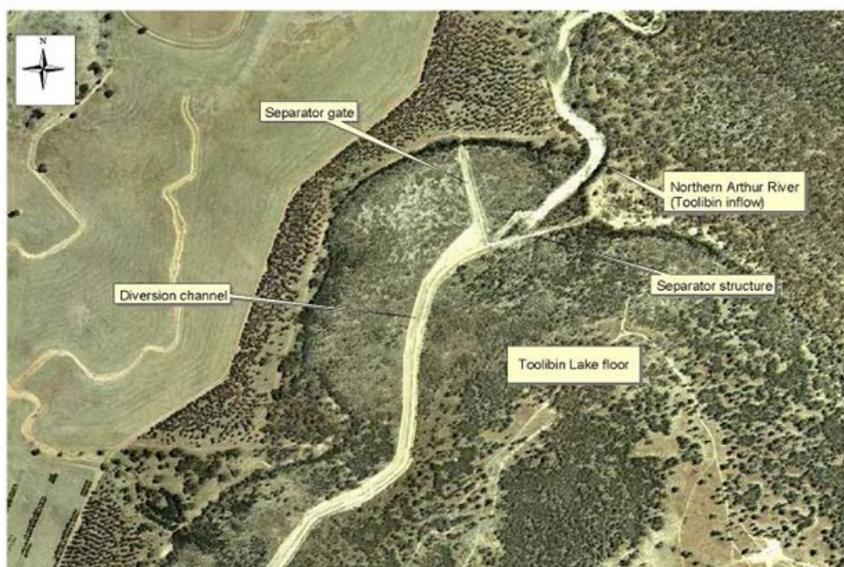
Separator Gate \ Diversion Structure

The diversion structure allows management to close the gates which diverts low volume, highly-saline water from flowing into Toolibin Lake.

The gates and structure divert up to $6\text{m}^3\text{/second}$ onto Taarblin Lake.

The 6.5 kilometre diversion structure was constructed in 1995 and successfully used for the first time in 1996.

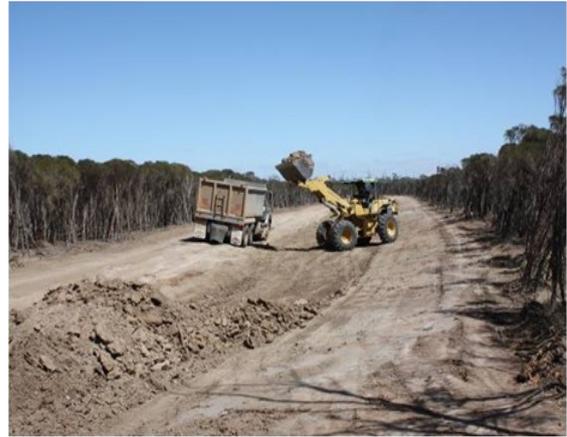
Vegetation & soil were removed for construction of the waterway

Construction began on 12 November 2007 when the waterway was cleared of vegetation and topsoil before progressive removal of the subsoil upstream.

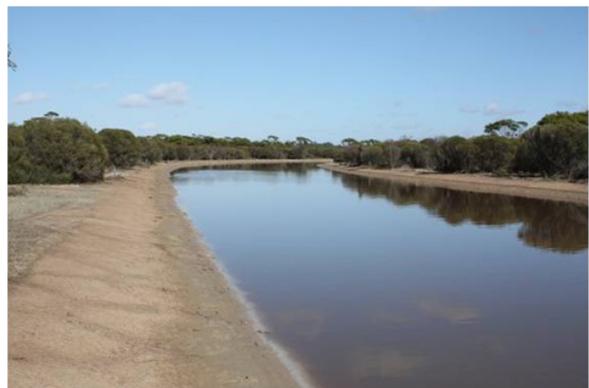
Dulbining waterway

The waterway improves the conveyance of water through Dulbining Nature Reserve by controlling highly-saline surface water-logging, inundation and lower the salt storage above Toolibin Lake by reducing ponding and salinisation.

The waterway is about 6 kilometers in length extending from North Toolibin Rd down to Dulbining Lake near Wickepin-Harrismith Rd. The width varies from 3 metres for minor channels to 20 metres where the waterway terminates at Dulbining Lake.

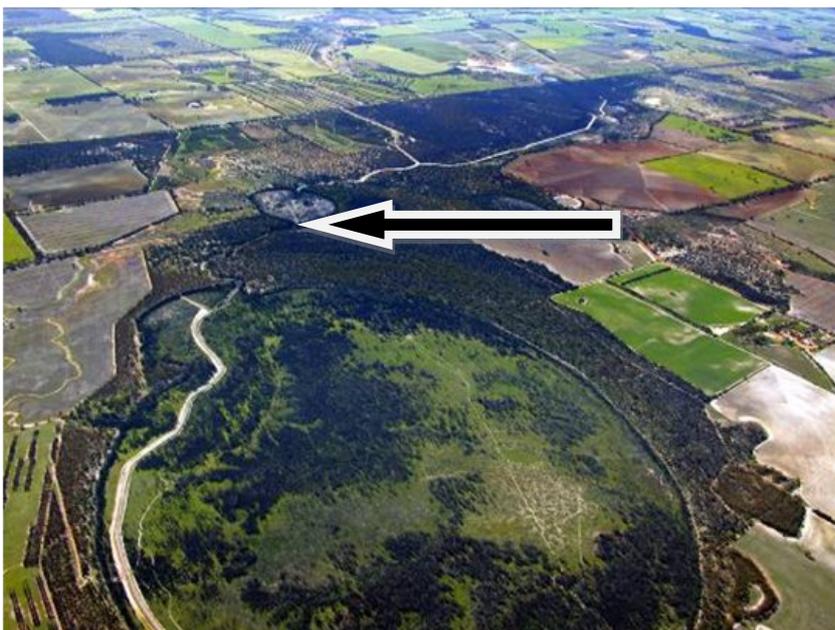
The channels at the top of the picture is the waterway which terminates at Dulbining Lake.

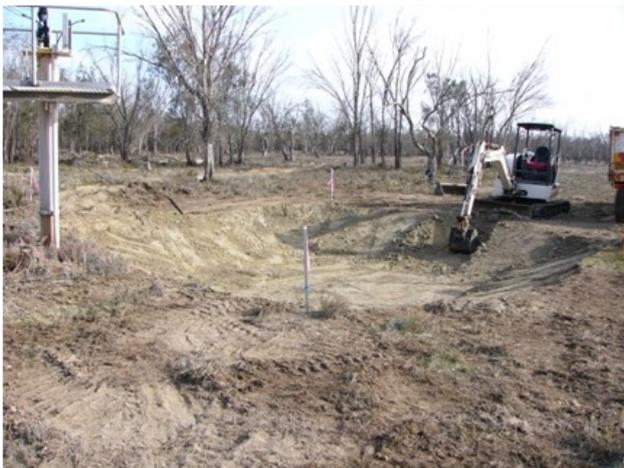
Construction of the sump

The construction of channels will allow the removal of water from low lying areas of the lake to a sump. If the salinity levels exceed limits of acceptable change the water will be pumped from the sump into the diversion structure and eventually out to Taarblin Lake.

Work occurred in May 2010 with the construction of two channels and the sump. Other minor channels will be completed as required. Approximate Cost \$60,000.

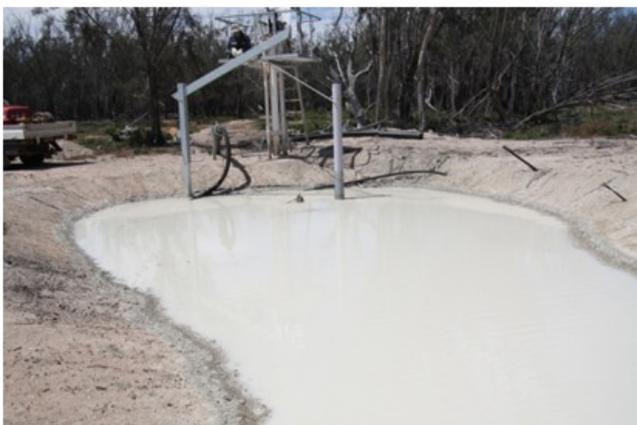
The sump and pump

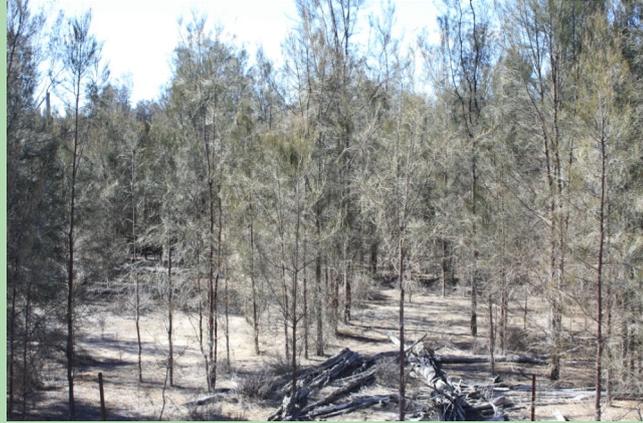
Regeneration around pump 9 (2011)

Mass germination occurred after a heavy summer rainfall event in 1998 around pump 9. Monitoring plots were established to monitor the success of regeneration.

Regeneration has been successful in certain areas of the lake floor, particularly around pumps where there is significant groundwater draw-down .

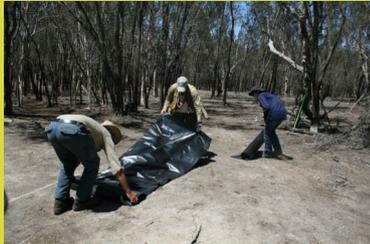
A rectangular bund was constructed on the lake bed.

The bund contained more than 100 trees, with some trees fitted with sensors to measure tree girth, sap flow, and measure water and soil parameters. Over two weeks, 100 000 litres of fresh water was applied to the bund and a water depth of more than 30 centimetres was maintained for seven days.

The trial confirmed the different rooting depths of the trees and demonstrated that they can rapidly increase water use following flooding, particularly the sheoak. The discovery of different root zone niches used by the two species (sheoak roots are shallower than the paperbark's) helps to explain the sequence of tree deaths that has occurred and the ecological requirements that management must consider.
